# UNDERWATER BRIDGE INSPECTION REPORT

STRUCTURE NO. 9517

SOUTH CHANNEL OF THE ST. LOUIS RIVER

DISTRICT 1 - CARLTON COUNTY, CITY OF CLOQUET

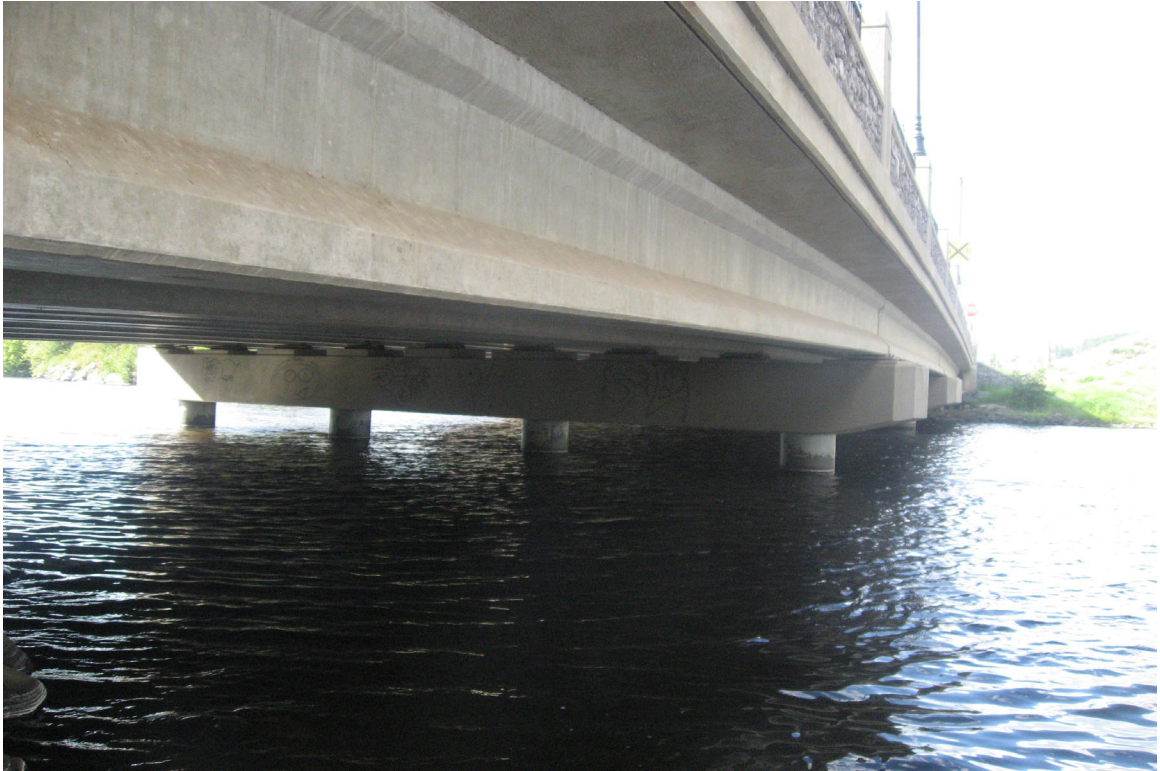
Photograph 1. View of Pier 1, Looking North.

- (A) The steel pipe piles exhibited minor coating failure and up to 1/2-inch-diameter rust nodules on 5 to 10 percent of the surface area mainly around waterline with no related section loss. Pitting was observed with 1/32 inch maximum depth.
- (B) A moderate accumulation of timber debris on the channel bottom was observed at the upstream end and randomly scattered throughout Pier 1, extending from the channel bottom up 3 feet.

- (A) Reinspect the submerged substructure units at the normal maximum recommended (NBIS) interval of five (5) years.

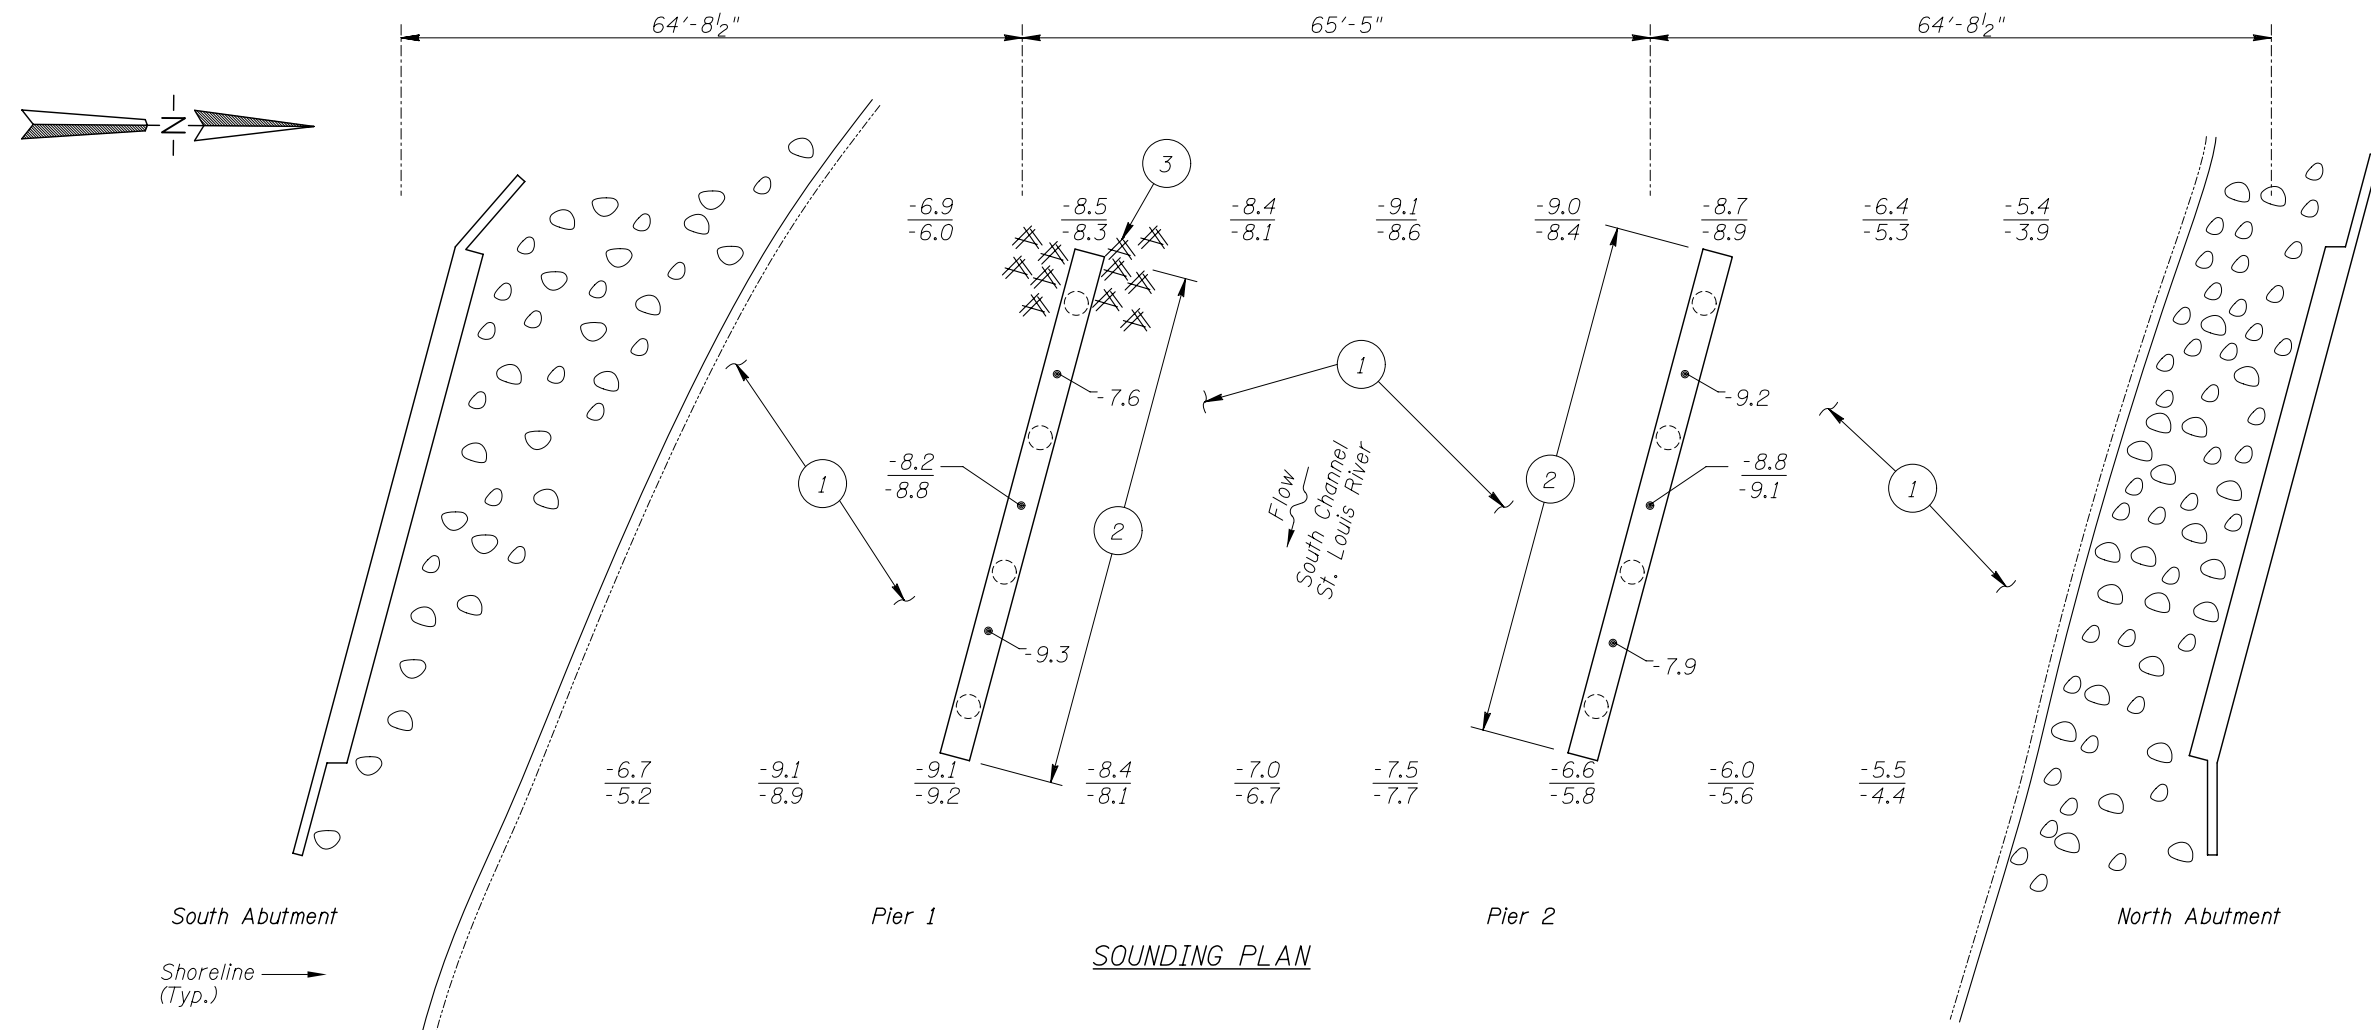
- 1 The channel bottom material consisted of 1- to 3-foot-diameter riprap with no probe rod penetration.
- 2 The steel pipe piles exhibited minor coating failure and up to 1/2-inch-diameter rust nodules over 5 to 10 percent of the surface area (mainly around waterline) with no related section loss. Pitting was observed with 1/32 inch maximum depth.
- 3 A moderate accumulation of 1-foot-diameter and smaller timber debris was observed on the channel bottom at the upstream end and scattered throughout Pier 1. Debris extended from channel bottom up 3 feet.
